NATIONAL ADVISORY COMMITTEE FOR AERONAUTICS

TIDEWATER AND WEATHER-EXPOSURE TESTS ON METALS

USED IN AIRCRAFT - II

TECHNICAL NOTE No. 842

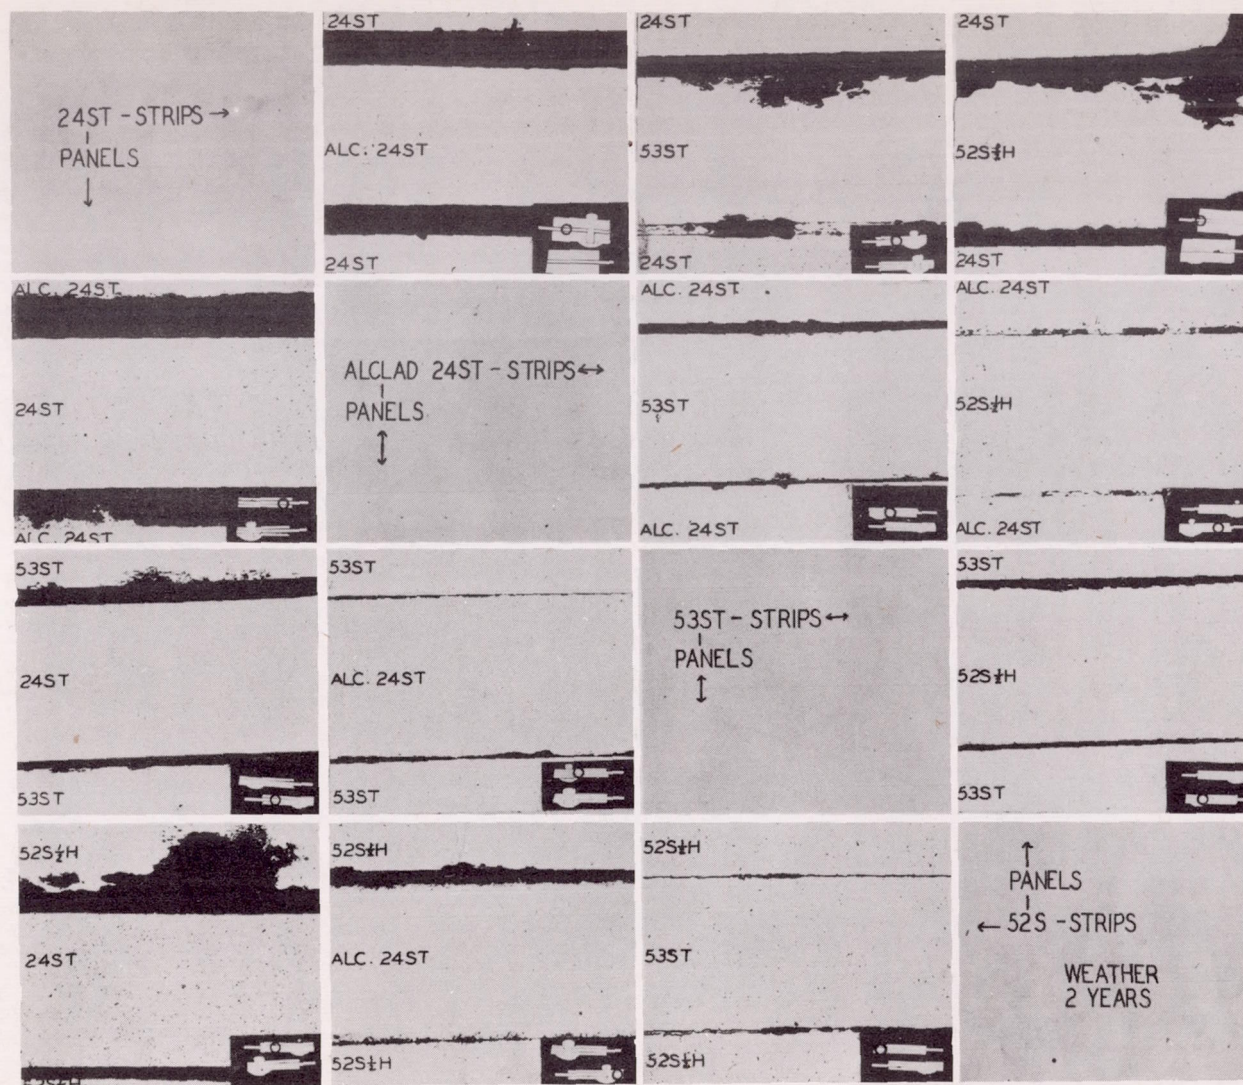
Figure 17.- Cross sections showing aluminum alloys exposed to the weather in contact with each other. Corrosion owing to electrolytic effects were similar to those observed in the tidewater tests but were usually less severe. Photomicrographs, x 25; smaller cross sections, x 1/2.

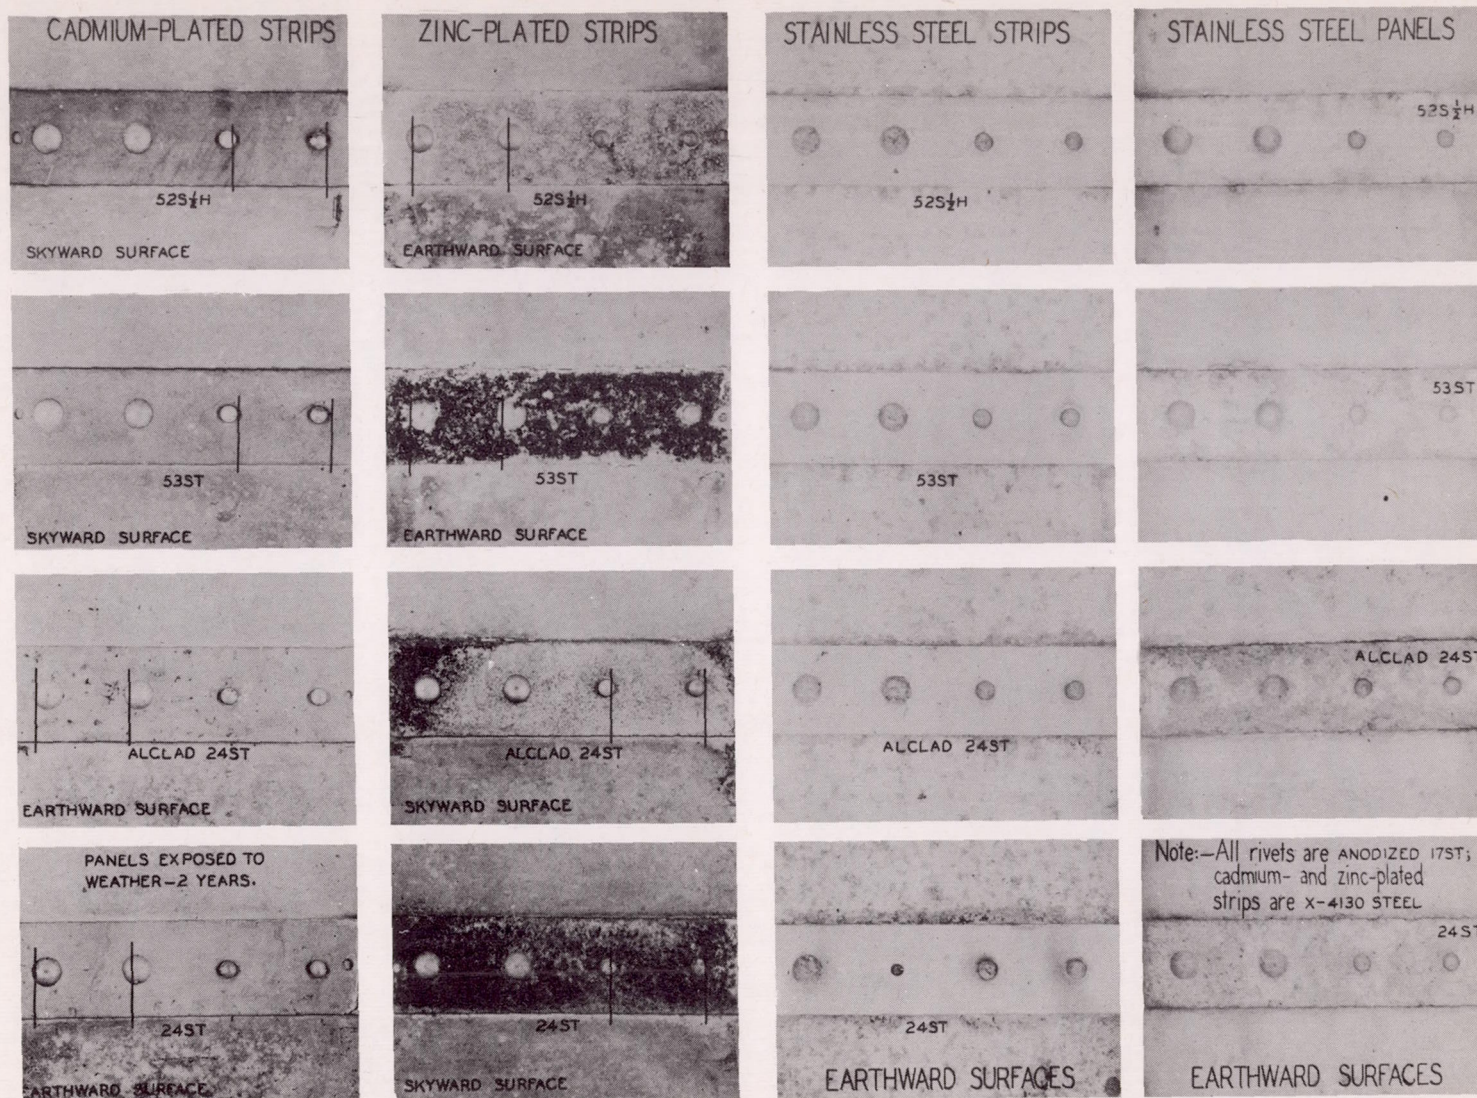
The cadmium-plated strips exposed for 2 years to the weather were all in excellent condition (fig. 18) although faint traces of rust were visible on the strip in contact with Alclad 24ST. The zinc coatings were entirely corroded off strips in contact with Alclad 24ST, were mostly off when in contact with 53ST, but were fairly intact when joined to 24ST and 52S- $\frac{1}{2}$ H sheets. Microscopic examinations revealed little corrosion at the faying surfaces of either coating with the aluminum-alloy sheets except near the edges of the strips, where the attack on the aluminum alloys was usually very severe (fig. 19 and table II). The results at the end of the second year, in general, demonstrate that zinc is anodic to all the aluminum alloys tested and that cadmium is either slightly cathodic or has a potential equivalent to that of these alloys. The tests show that zinc sheets attached to aluminum alloys may be sacrificially attacked and prevent corrosion of the aluminum where cell action can be maintained more or less continuously.

Figure 18.- Aluminum-alloy panels in contact with SAE X4130 steel having electro-deposited coatings of zinc and cadmium, and with stainless steel. Cadmium-plated strips remained in relatively excellent condition,

but the zinc coatings were in either partial or complete stages of disintegration. Corrosion products at the faying surfaces of one of the 24ST-stainless steel combinations separated the metals enough to cause one of the rivet heads to break off. x 1/2 (15-16).

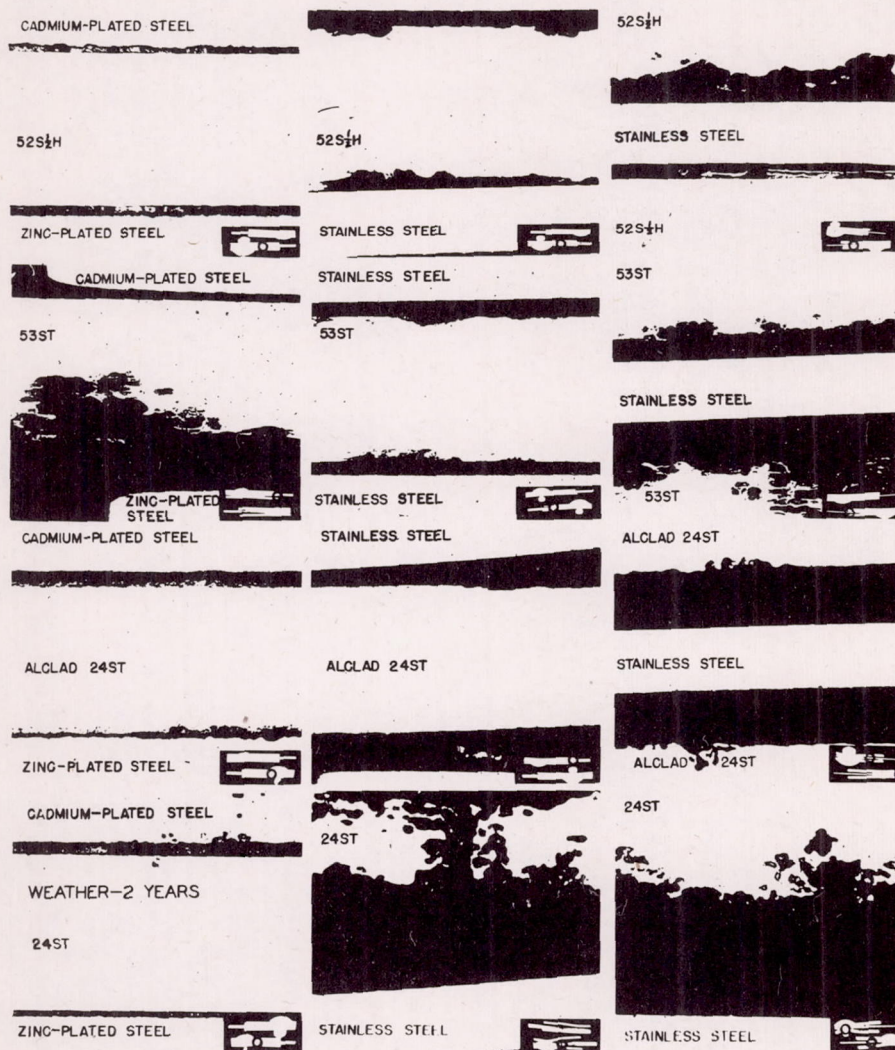
Figure 19.- Cross section showing aluminum alloys exposed to the weather in contact with electrodeposited coatings of cadmium and zinc or with stainless steel. Attack at the faying surfaces was usually deepest on the main panel at areas near the edges of the strips, especially when corrosion products were present in quantity. Photomicrographs, x 25; smaller cross sections, x 1/2.

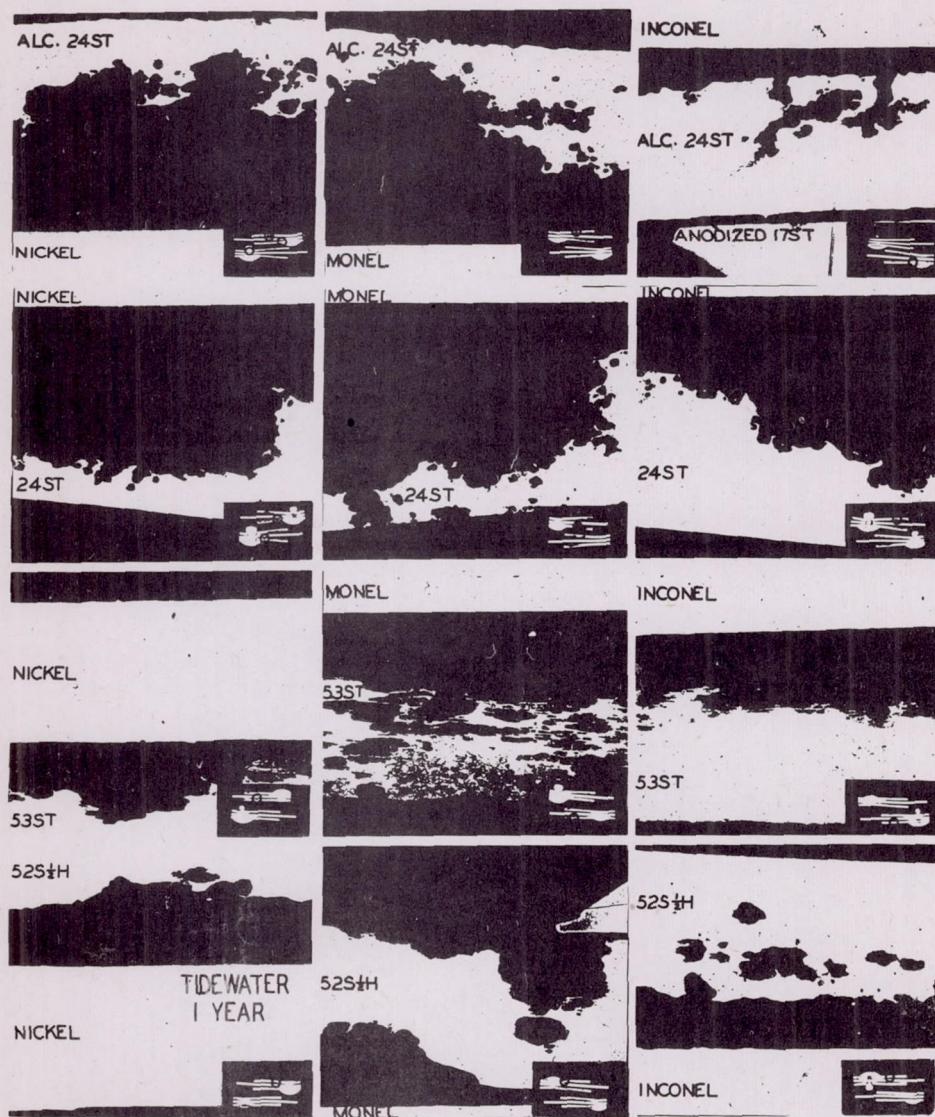
Contacts of aluminum alloys with nickel alloys.— The aluminum alloys formed the 1- by 4-inch strips attached to main panels of nickel, monel metal, or Inconel. Microscopic examinations of the panels exposed for 1 year to tidewater (fig. 20 and table II) indicated that the aluminum alloys were probably more anodic to the nickel alloys than to the stainless steels. Monel-aluminum alloy couples resulted in the worst corrosion on aluminum, but the corrosion was sufficiently severe with all these combinations to indicate that coupling with these nickel alloys should be avoided. Cracks resulting from the combined action of stresses and corrosion were found on all strips of 24ST and Alclad 24ST in contact with these alloys.

Figure 20.- Cross sections showing nickel alloy panels exposed to tide-water in contact with aluminum alloys. Attack on the aluminum alloys was very severe in every instance. Note the stress-corrosion cracking on the Alclad 24ST strips joined to Inconel (upper right corner). Photomicrographs, x 25; smaller cross sections, x 1/2 (17).

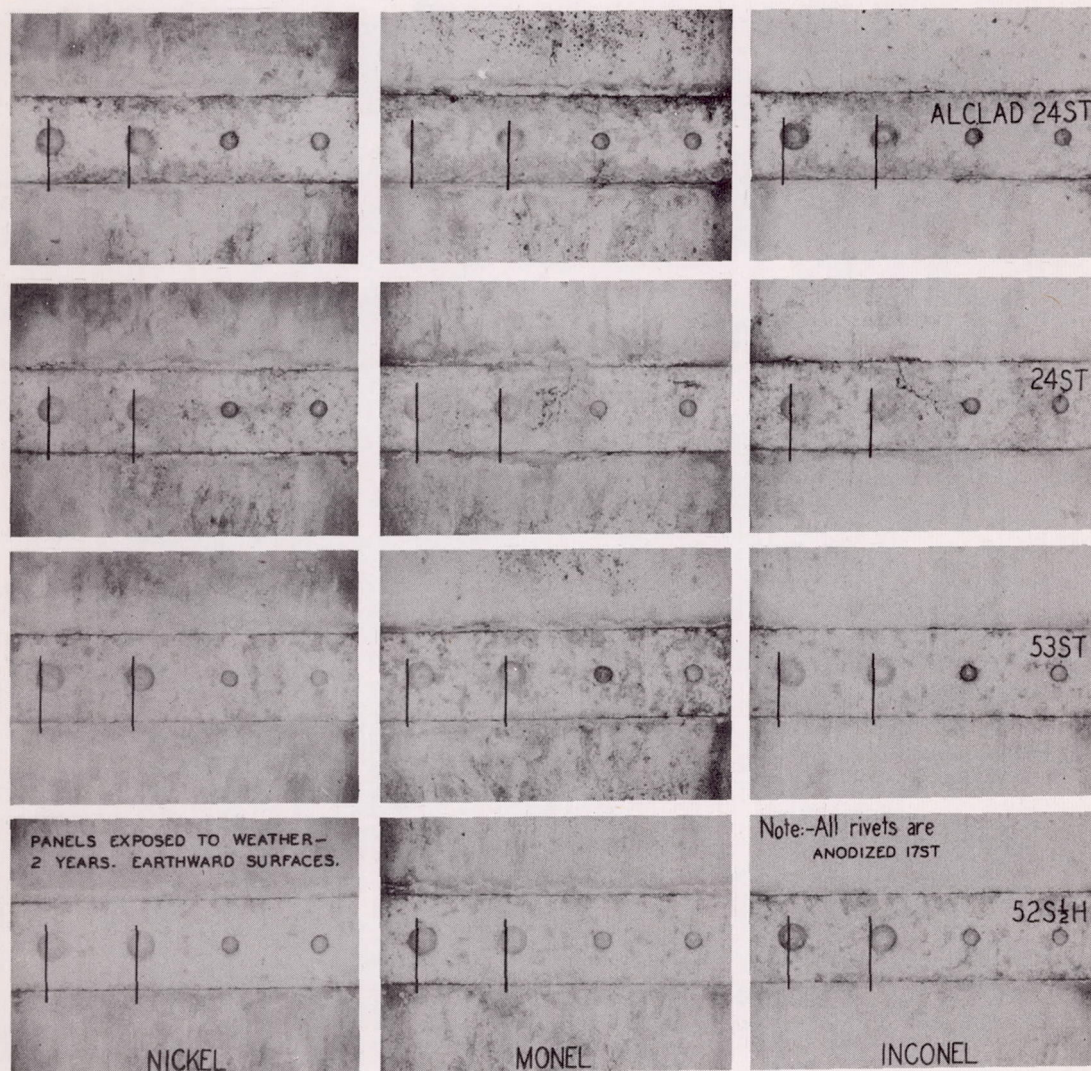
The panels exposed to the weather for 2 years were almost as severely attacked as those in tidewater for 1 year (figs. 21 and 22 and table II) as evidenced by the quantity of corrosion products at faying surfaces of the strips and the main panels. Cracks due to stress corrosion were present only on 24ST strips.

Figure 21.- Nickel alloy panels exposed to the weather in contact with aluminum alloy strips. The presence of considerable corrosion products along the edges of the strips indicates severe attack owing to electrolytic effects. x 1/2 (17).

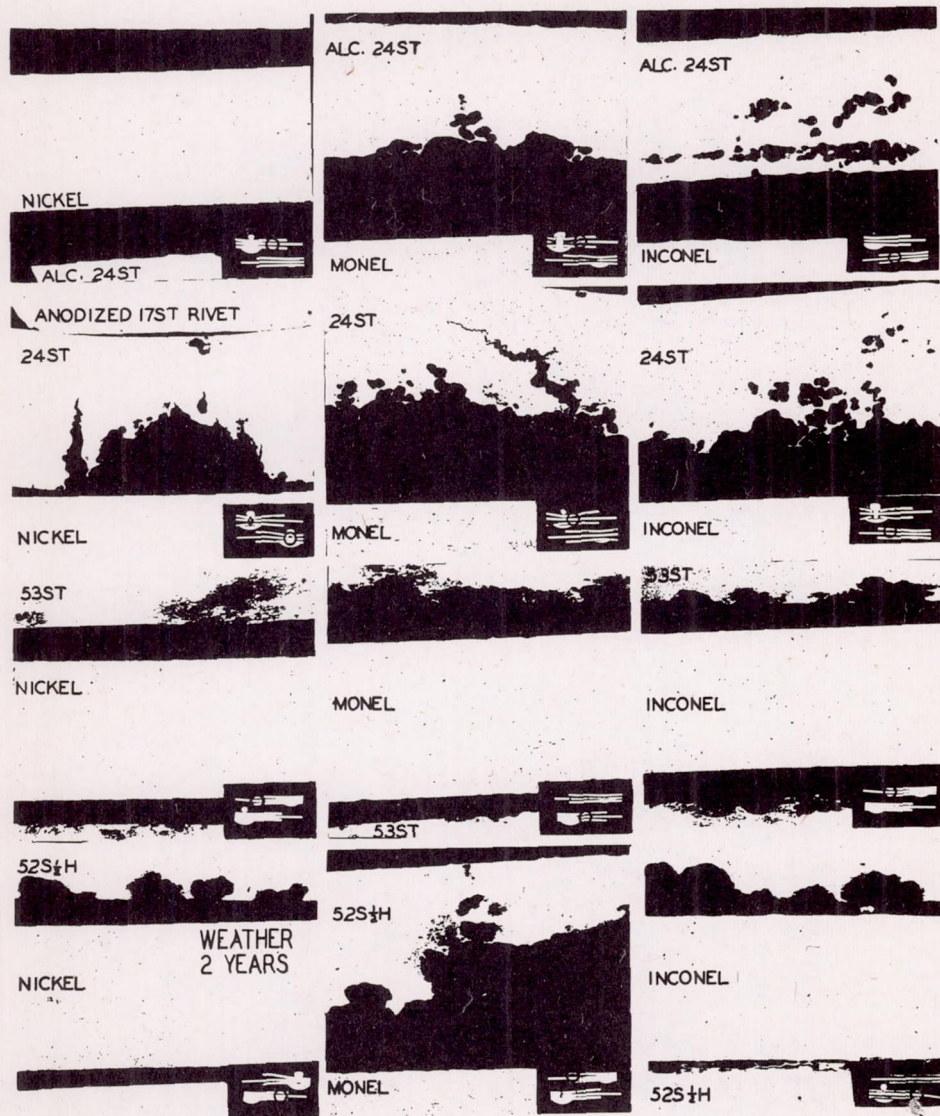
Figure 22.- Cross section showing nickel alloy panels exposed to the weather in contact with aluminum alloys. Compare with Figure 20. Note cracks on 24ST strips in contact with nickel and monel metal. Photomicrographs, $\times 25$; small cross section, $\times 1/2$.

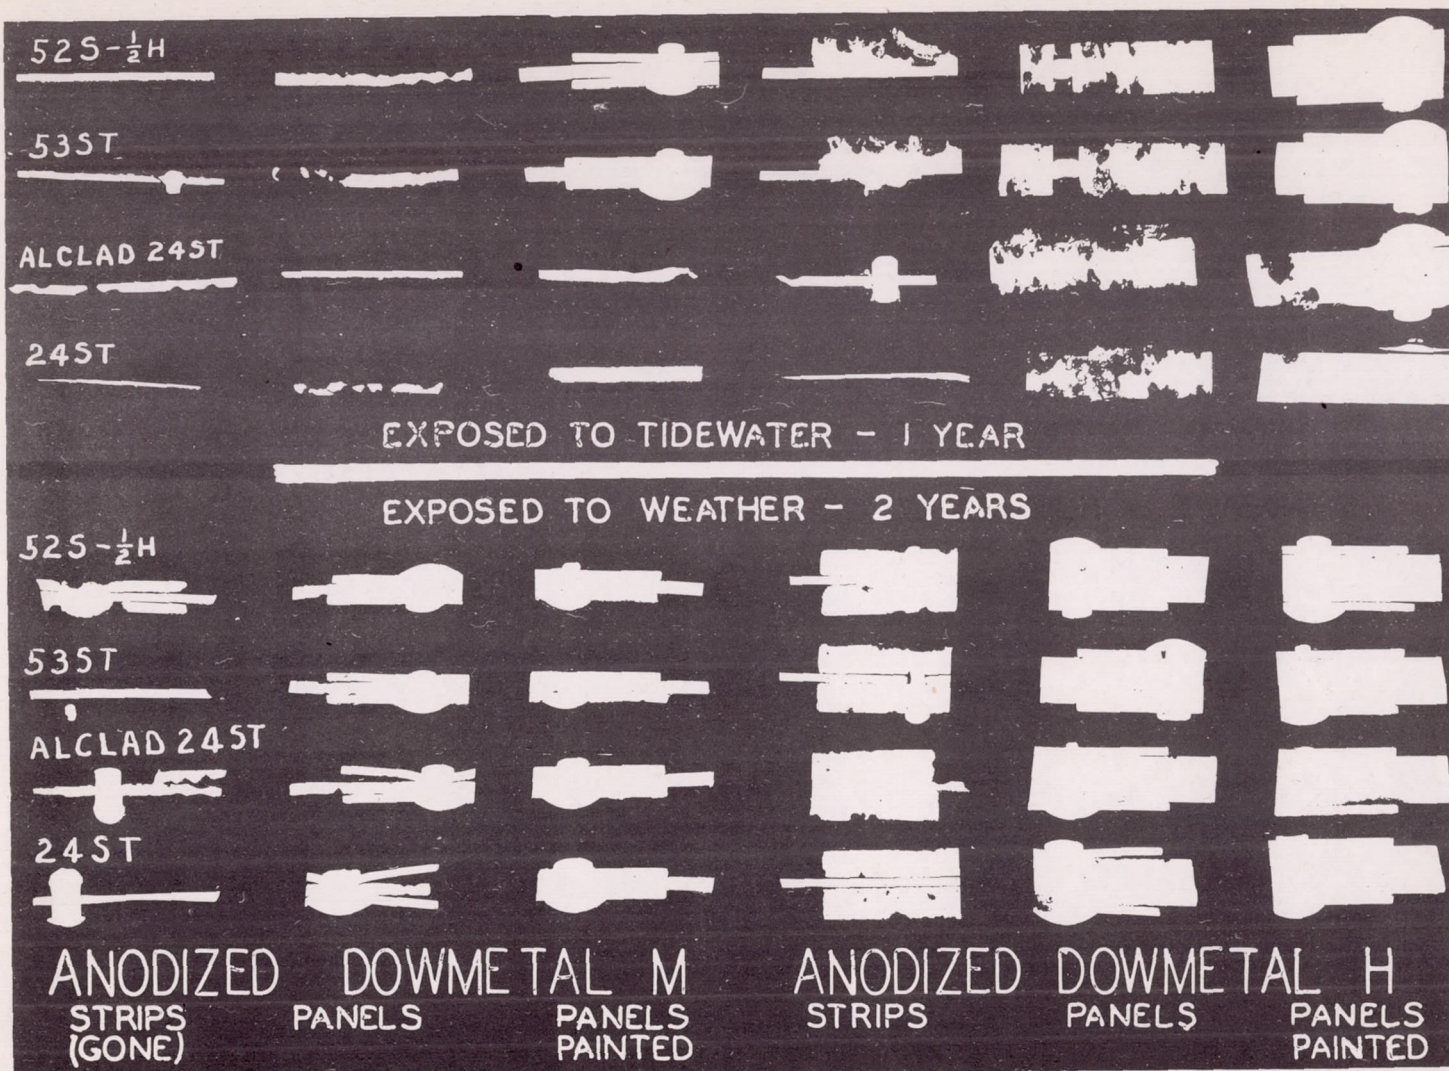
posed to the weather (fig. 23), but the painted panels were in relatively good condition after 2 years (figs. 23, 24, and 25). The panels were painted with 1 coat of Watson Standard Dowmetal Primer No. 1 plus 3 coats of Brooklyn Varnish No. 74 pigmented with $1\frac{1}{2}$ pounds of aluminum paste per gallon. The photographs illustrate that corrosion was much less severe where Dowmetal H, instead of Dowmetal M, was coupled with the aluminum alloys.

Figure 23.- Cross sections showing aluminum alloys exposed to tidewater and to the weather in contact with magnesium alloys. The magnesium alloys were the strips attached to larger areas of aluminum alloys in the first and fourth vertical columns; in the other vertical columns the aluminum alloys were the strips. Panels in the tidewater tests were in advanced stages of disintegration, except when painted. Unpainted panels with Dowmetal M strips were also severely attacked in the weather. x 1 (18).

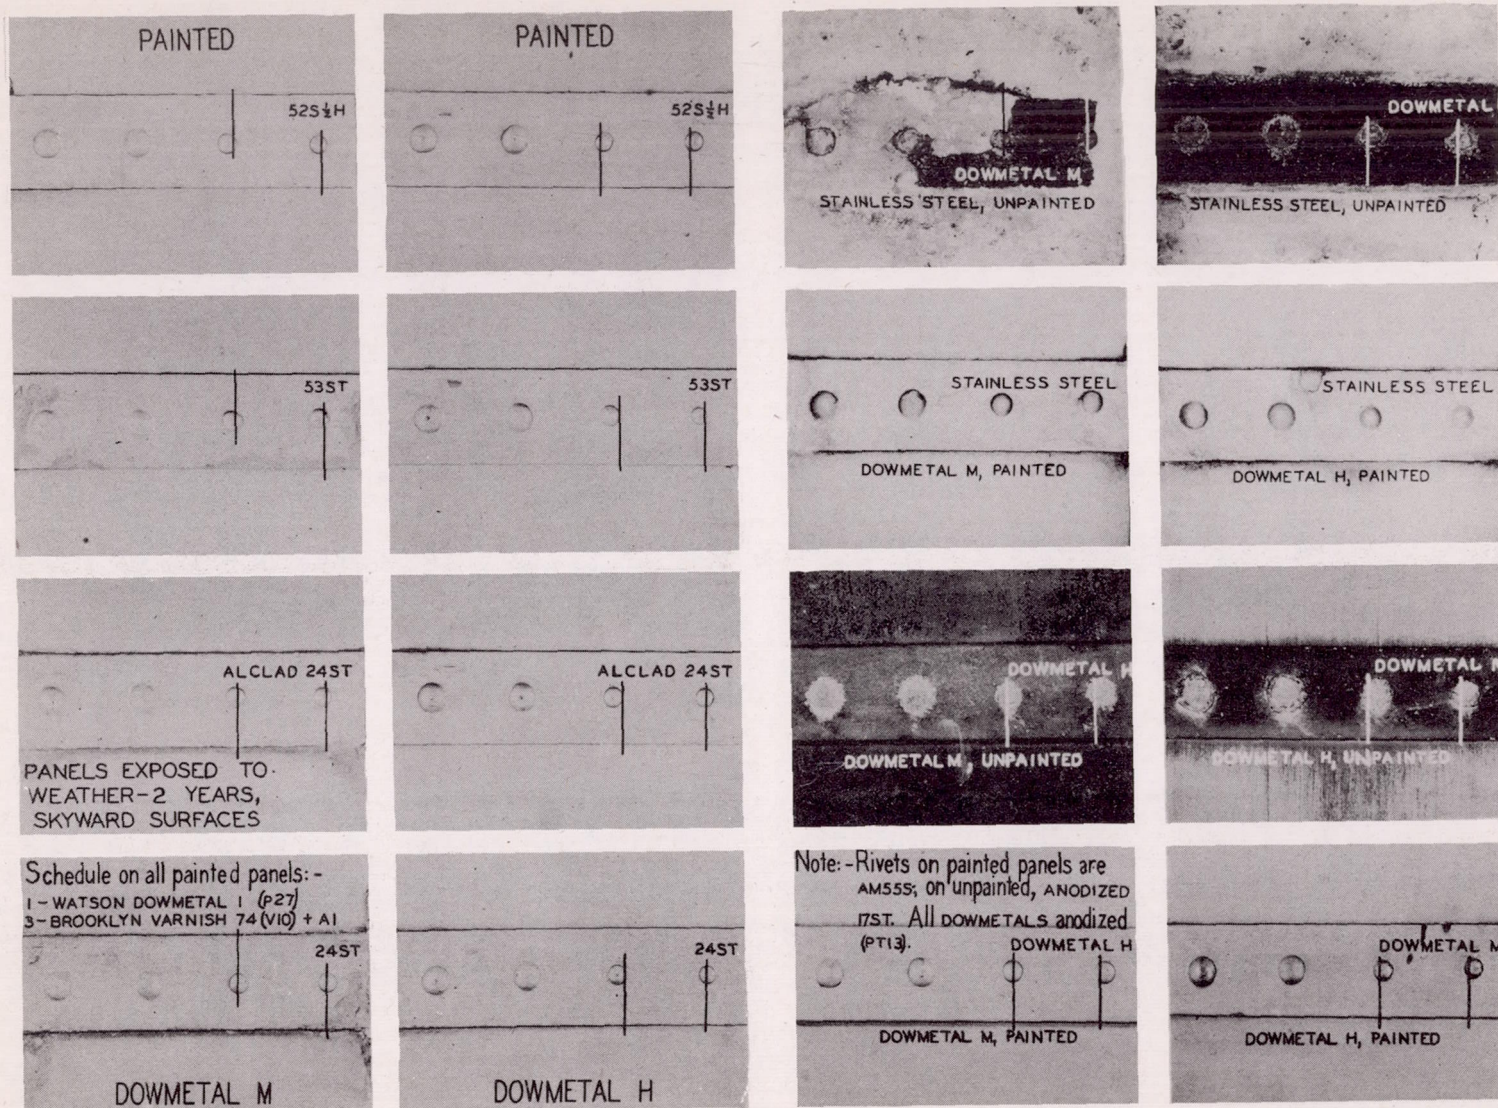
Figure 24.- Surface appearance of panels exposed to the weather with magnesium alloys in contact with each other, with aluminum alloys, or with stainless steel. The painted panels remained in relatively good condition. x 1/2 (19-20).

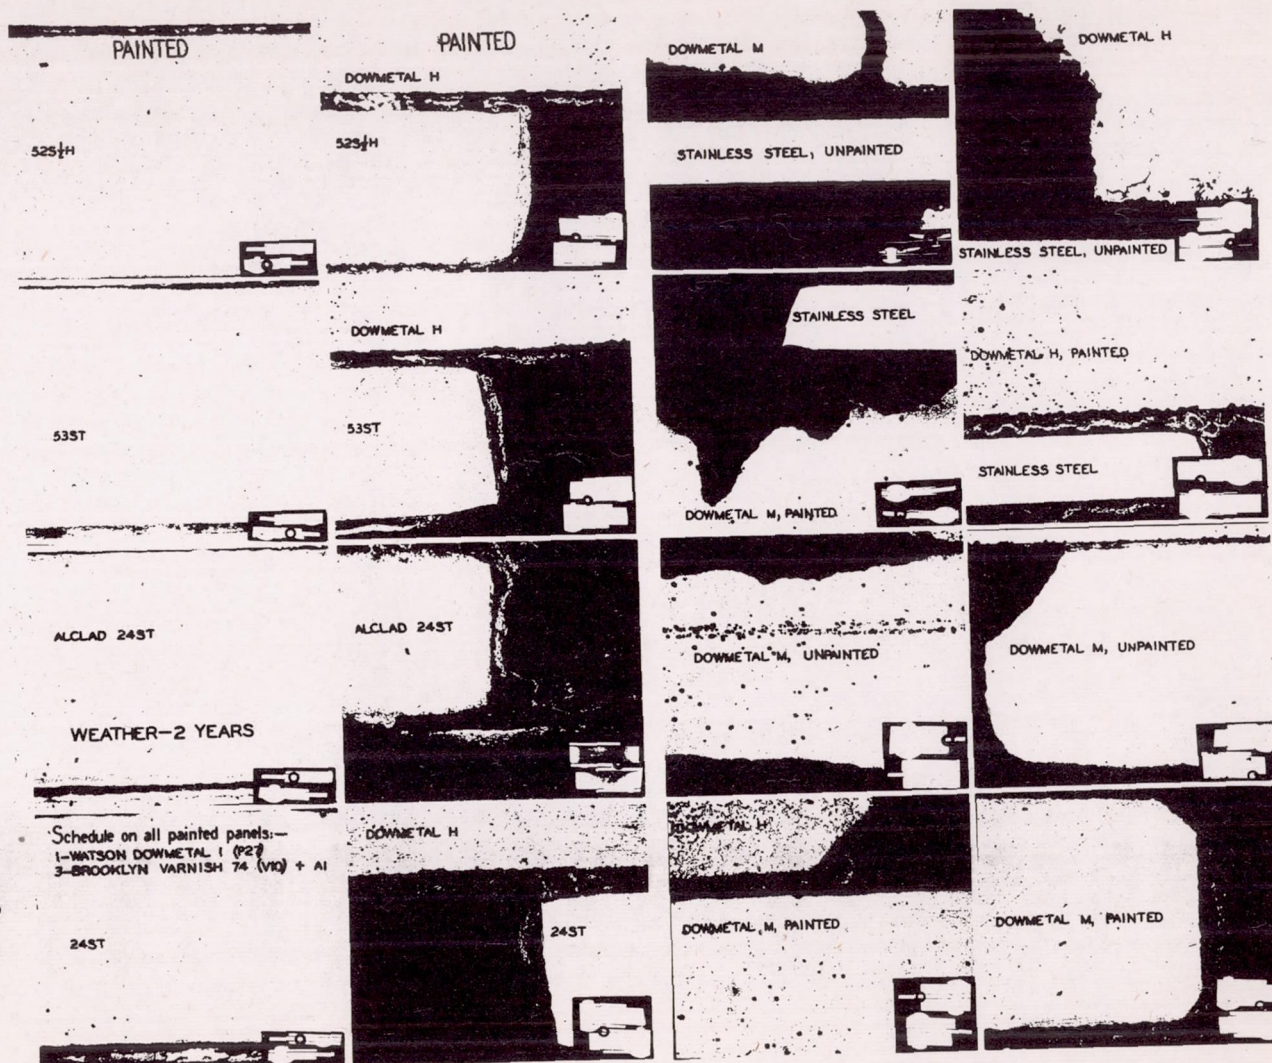
Figure 25.- Cross sections of panels exposed to the weather with magnesium alloys in contact with each other, with aluminum alloys, or with stainless steel. Painting was effective in preventing electrolytic reactions at the flaying surfaces except near the edges of Alclad 24ST, 24ST, and stainless-steel strips. Severe corrosion was present on corresponding unpainted panels. Photomicrographs, x 25; smaller cross sections, x 1/2.

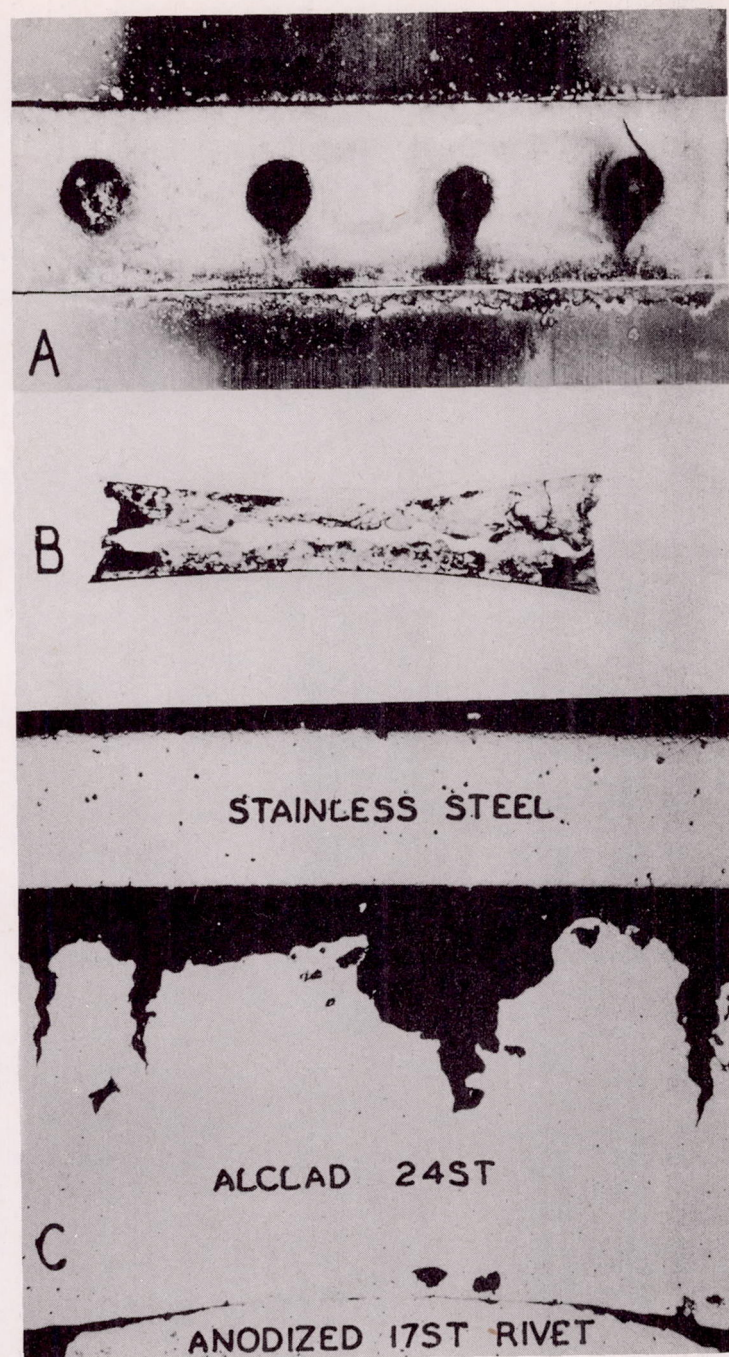
Stress corrosion.— The presence of cracks, which tended to follow intercrystalline boundaries, was noted on the following: (1) 24ST strips coupled with the nickel alloys or stainless steel, in both the tidewater and weather tests; (2) Alclad 24ST strips coupled with the nickel alloys or stainless steel (fig. 26) in the tide-water tests only; (3) Dowmetal H strips joined to 24ST and 52S- $\frac{1}{2}$ H alloys, after 2 years of exposure to the weather; (4) stainless-steel strips joined to Dowmetal M (fig. 26), after 2 years of exposure to the weather.

The cracks were undoubtedly caused by the combined action of corrosion and stress. The stresses were markedly increased by the accumulation of corrosion products

at the faying surfaces. It was suspected that the presence of the compound $HgCl_2$ among the corrosion products may have augmented the cracking of the stainless steel strips on Dowmetal M panels. Microanalytical and electron diffraction tests, however, indicated that no solid phase of that compound was present. The products were adjudged to consist mainly of a jelly of hydrous magnesium carbonate. Between the steel and the Dowmetal M sheet and adjacent to the steel there was a film of nearly opaque white matter. Next to the magnesium was a translucent, dense, slightly amber layer containing an undissolved residue in which iron rust predominated.

Figure 26.- Examples of stress-corrosion. A - Crack on stainless steel strip joined to Dowmetal M panel. x 1. B - Cross section showing large amount of corrosion product present on couple of (A). x $2\frac{1}{2}$. C - Cracks in Alclad 24ST strip attached to a stainless steel panel. x 50.

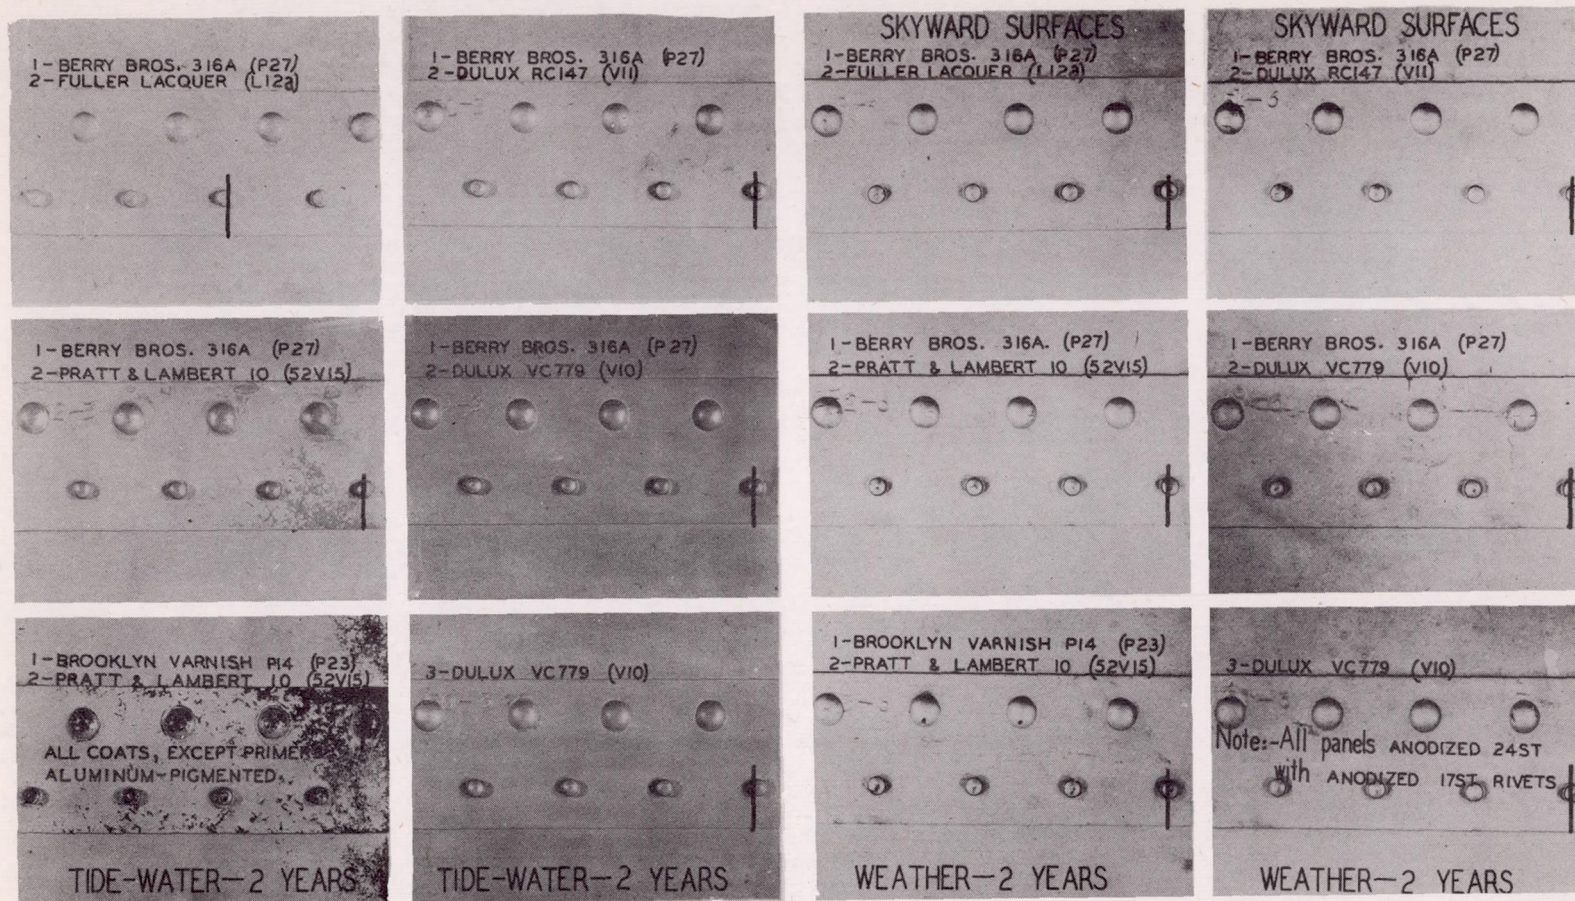
Paints on anodized 24ST aluminum alloy.— The paint schedules (fig. 27) applied to 24ST aluminum alloy were generally in excellent condition in both the tidewater and the weather-exposure tests at the end of 2 years. In the tidewater tests aluminum-pigmented finish coats of Fuller lacquer (Navy specification L12a) and of Pratt and Lambert Number 10 aluminum mixing varnish (Navy specification 52V15b) failed to adhere in some areas when applied, respectively, over Berry Brothers 316A Primer (Navy specification P27) and Brooklyn Varnish P-14 Primer (Navy specification P23). Microscopic examinations, however, revealed no corrosive attack on any of the painted panels.

Figure 27.- Skyward surfaces of anodically treated 24ST panels exposed to tidewater or to the weather with various protective paint coatings. The finish coats on panels at the top and the bottom of the first vertical column at the left failed, in some areas, to adhere to the primers. This condition was somewhat more pronounced than at the end of the first year. The rest of the coatings were in excellent condition. x 1/2 (21).

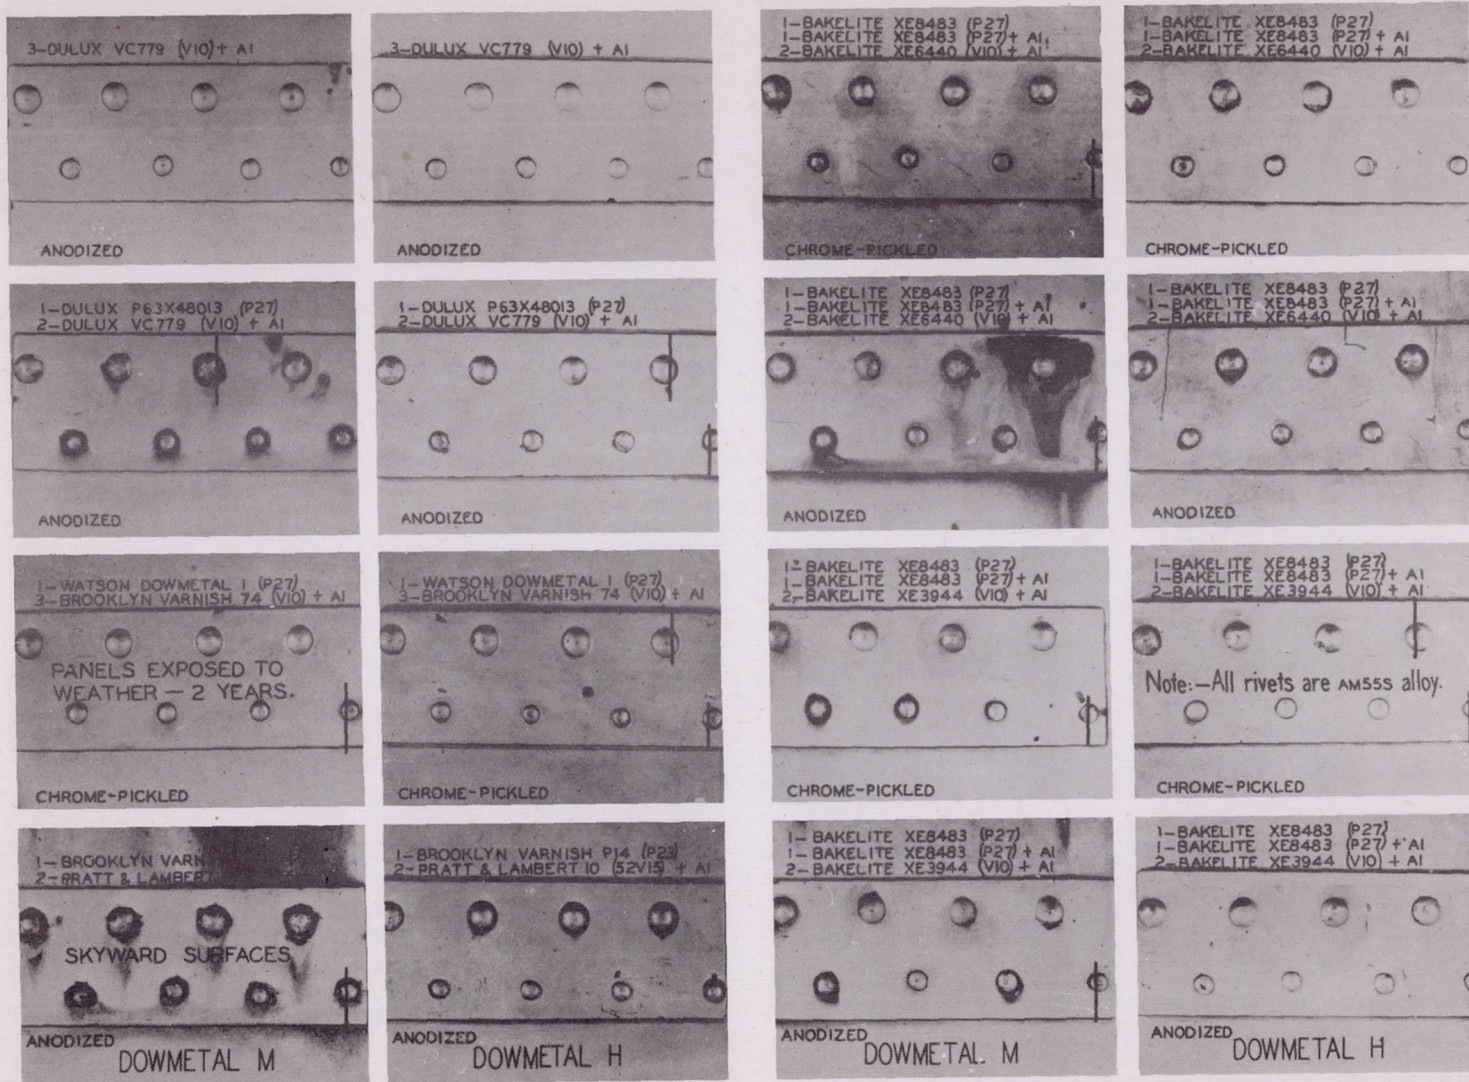
In the weather-exposure tests, at the end of the second year, most of the paints were in good condition (fig. 28). Failures were generally confined to the unanodized AM55S rivet heads and to the edges of the panels. Microscopic examinations (fig. 29) revealed occasional deep pits at areas adjacent to rivet heads.

Figure 28.— Surface appearance of magnesium alloys exposed to the weather with various protective paint coatings. Most of the paints remained in good condition, except at the rivet heads and at the edges of the strips of the main panel. x 1/2 (22).

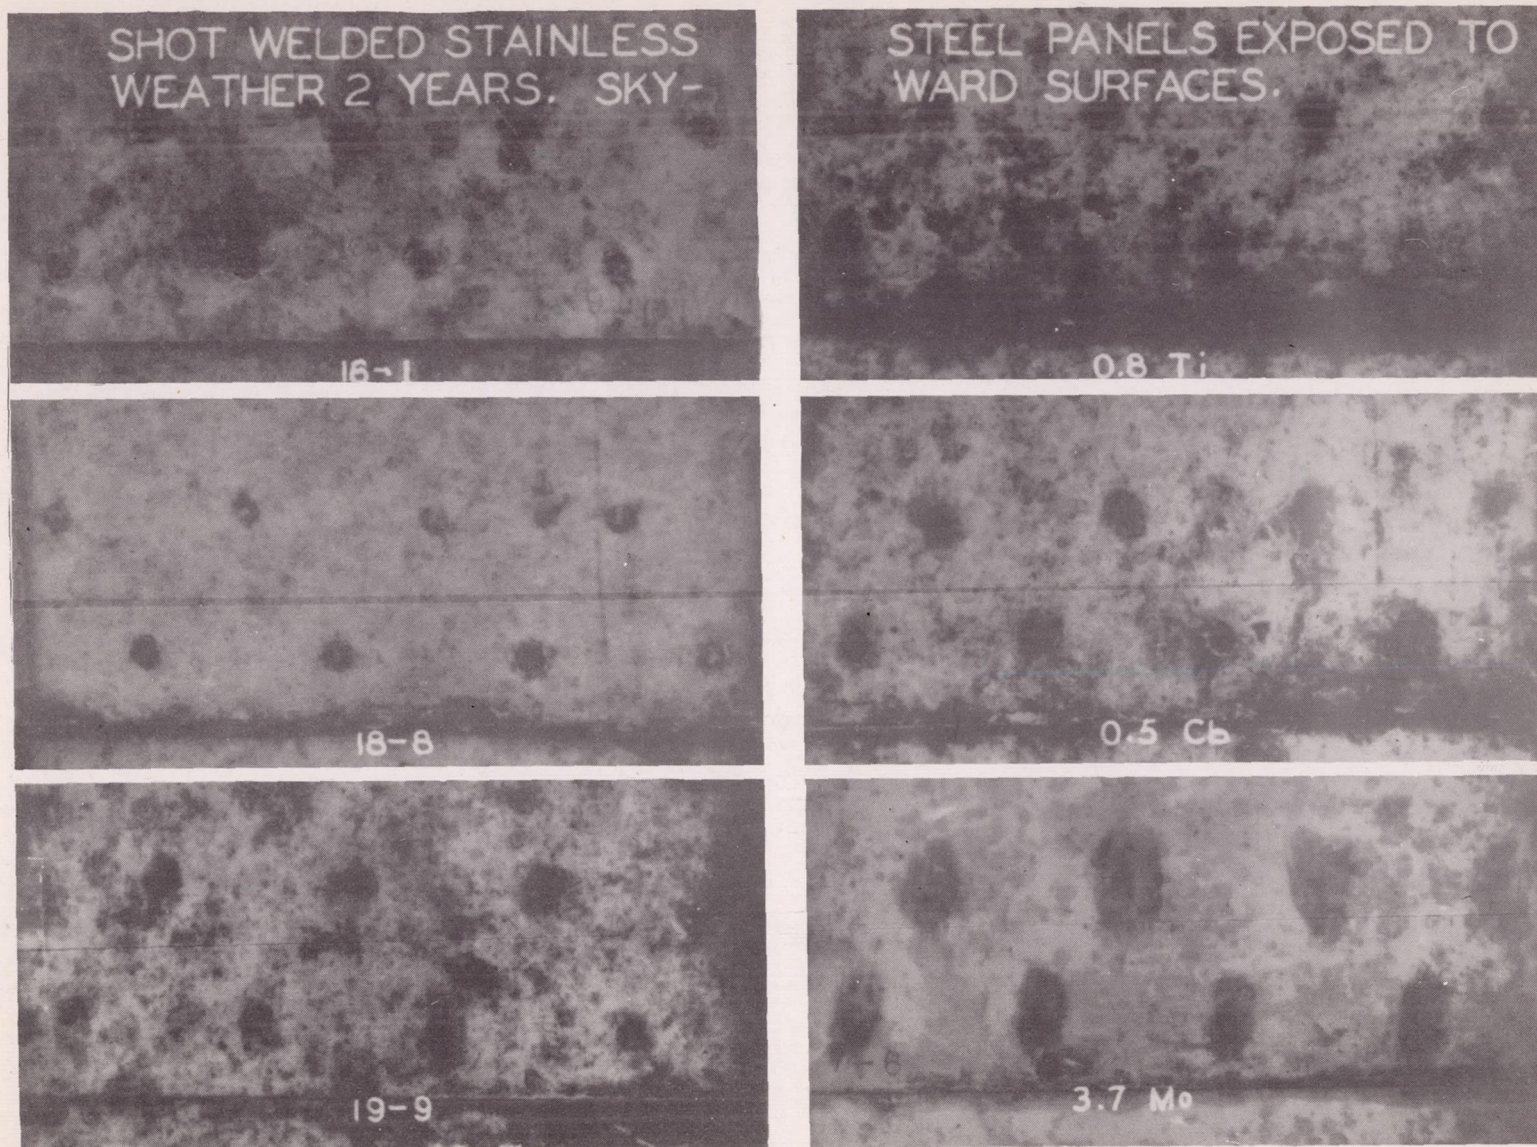
The panels exposed to tidewater at the end of the second year still exhibited practically no rust except for a number of localized areas on the 16:1 chromium-nickel alloys. Rust on the panels exposed to the weather was greater in extent and somewhat more heavily deposited at the end of the second year than at the end of the first year (fig. 31). Rusting continued to be worse on the 16:1 alloy, and notably much less on the steel containing

Figure 31.- Stainless steel panels of various compositions, exposed to the weather. Rust deposits were considerably heavier at the end of the second than the first year. Figures in the left column indicate percentages of chromium and nickel, respectively. Figures in the right column give the percentage of the addition element shown. Rust on the welds was generally worse than on the rest of the panels. Deposits on the steel containing molybdenum were very much lighter than on the other steels. x 1 (26).
